## SAFETY ALERT

ISSUE # 08-2022

## Worker Fatality by Mechanical Asphyxiation

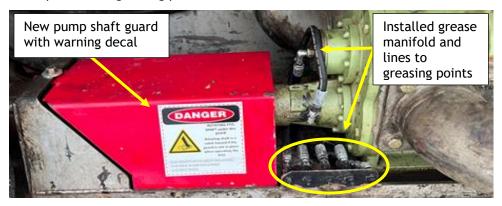
View of modified guard and grease manifold

- Installed a grease manifold so drivers do not need to lean over the pump when conducting greasing activities.
- Changed guards on all trucks to a type that fully covers the shaft's catch hazards and is more difficult to remove.
