# DRILLING MUD CENTRIFUGE FAILURE

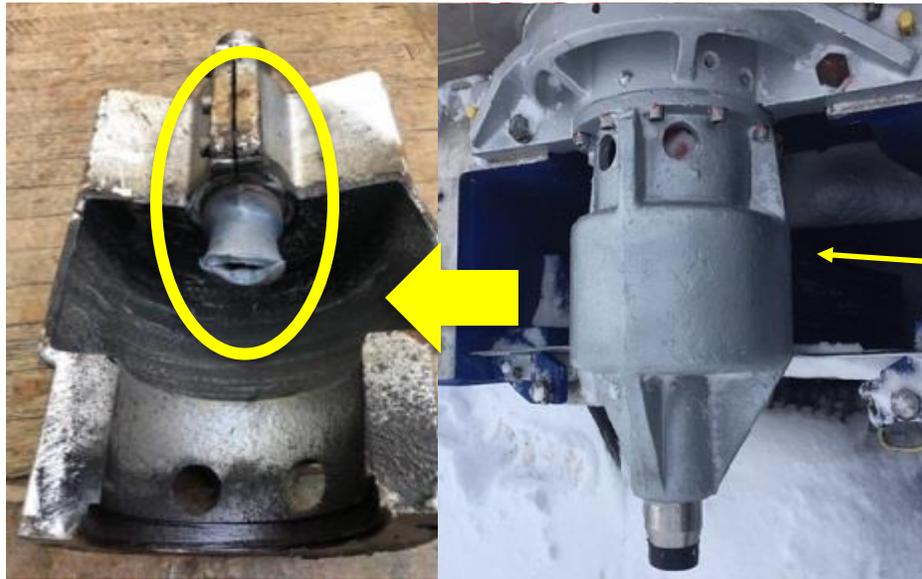
Housing around the feed tube

An employer experienced an equipment failure of a skid-mounted solids centrifuge. The feed tube detached from the centrifuge because of vibrations from mounting bolts that had backed out. The feed tube detached, causing the steel housing around it to be ejected. No personnel were in the area where the housing landed.

**LEFT:** THE HOUSING (SHOWN IN PHOTO ON RIGHT) IS TURNED OVER, SHOWING THE FEED TUBE FAILURE

**RIGHT:** NORMAL INSTALLATION OF THE FEED TUBE AND HOUSING

Vibrations from the loose bolts caused the feed tube to shear off from the centrifuge body, catapulting the housing.

The feed tube was projected approximately 18 meters (60 feet) from the unit onto a roof panel of the neighbouring mud tank, landing on the mats below

- Employers, including rental equipment companies, must ensure adequate QA/QC procedure to confirm the proper type and securement of bolts and other critical steps for high-RPM rotating equipment.
