Worker pinned between stump and iron roughneck POTENTIALLY SERIOUS INCIDENT

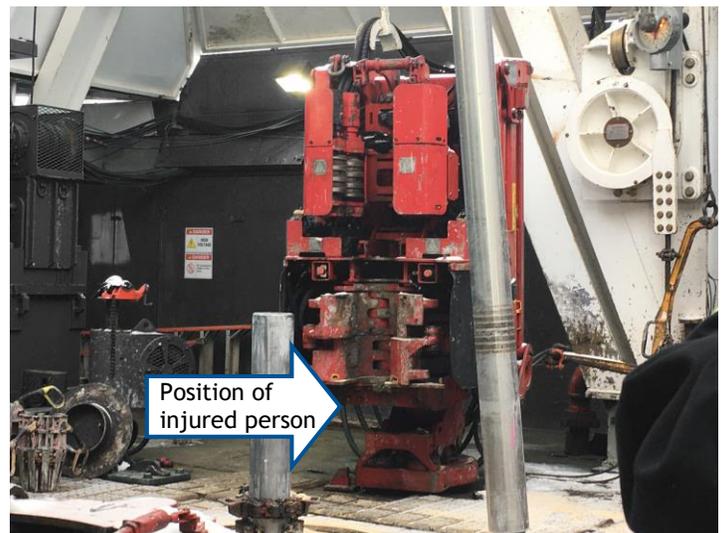
A rig crew was making up the bottom-hole assembly (BHA) with a third-party worker. The iron roughneck was inadvertently activated from the doghouse, extending it forward and pinning the third-party worker against the stump.

The iron roughneck had been moved from another rig, and the warning light and alarm had been removed for transport but not re-installed.

The iron roughneck was inadvertently activated with the 'sequence' button, which is seldom used. Safety meeting was held to review the job safety analysis (JSA) for handling BHA and the exclusion zone was reviewed.

- The worker hit the sequence button and inadvertently activated the iron roughneck
- The iron roughneck had not been de-energized when not in use.
- Manufacturer-supplied visual and audible safeguards were not installed on this piece of equipment.
- Safety meetings were held to review the line of fire hazards.

- ‘Sequence button’ has been disabled to prevent it from activating the iron roughneck. Operation is now only done from the rig-floor controls.
- A beacon light and audible alarm have been installed to indicate when the iron roughneck is operating.
- Inspection procedures are being updated to include function testing the iron roughneck’s audible and visual alarms.
- The JSAs’s are being updated to verify the iron roughneck is isolated during activities it is not required for (e.g. handling BHA, running casing, drilling ahead, etc.).
- Line of fire area between the iron roughneck and the stump is highlighted with high visibility matting.
- All parties must be present for the safety meeting to review the relevant JSA(s).
