SAFETY ALERT - #04 - 2010

WORKER INJURED WHILE SERVICING COIL REEL DRIVE CHAIN AND ROTATING JOINT

Function: Coil Tubing Servicing	Release Date: March 22, 2010
Incident Type: Injury Incident	Country and Region: Canada, Northern Alberta

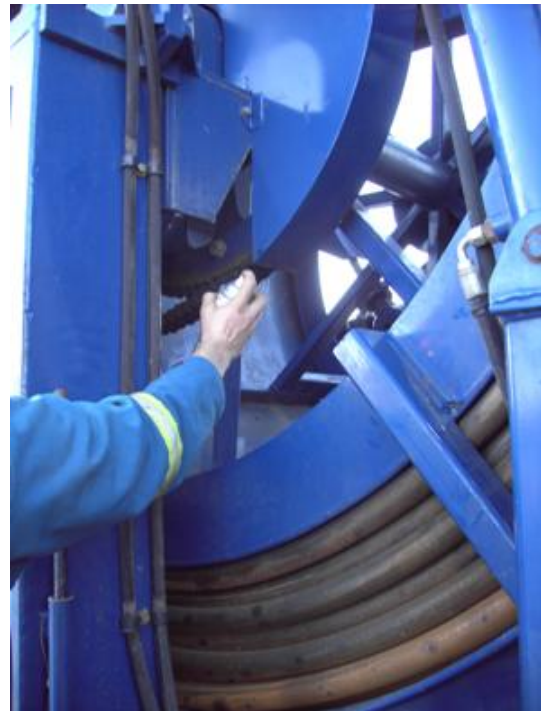
A worker was injured, while lubricating a coil tubing reel drive chain that was in motion.

While performing a coil tubing clean out on a well, a worker was injured as he was lubricating the coil reel drive chain. The worker stood beside the moving reel and sprayed chain lubricant onto the chain. The can of lubricant began to lose pressure, in response the worker moved closer to the drive chain. A spoke on the reel caught the workers arm; his arm was pulled into the support pedestal, which resulted in a severe laceration to his forearm.

- Preventive maintenance must not be performed on any moving equipment. When maintenance is required during a well servicing operation the coil tubing reel and rotating joint must be stopped and secured from any unintentional movement.
- During maintenance operations communication needs to be maintained between the equipment operator and maintenance worker to ensure all personnel are clear of the hazardous area before the operator reactivates the equipment.

- Companies may wish to consider installing remote or automatic lubricating devices on the coil tubing reel drive chain to prevent unintentional access to moving equipment.

- Companies may wish to install a barrier around the coil tubing reel to limit or prevent unintentional access to the area near the rotating equipment.
- All coil tube companies should review their procedures for equipment servicing during coil reel drive chain and rotating joint servicing operations, and revise as needed.
- Coil tube companies may wish to place warning signs to indicate to new workers, other workers, or visitors that rotating equipment hazards are present.
- Companies may wish to use an approved reflective tape or reflective paint to help workers identify when the reel is in motion.
