## Drill Line Cuts I-Beam Due to Incorrect Spooling POTENTIALLY SERIOUS INCIDENT

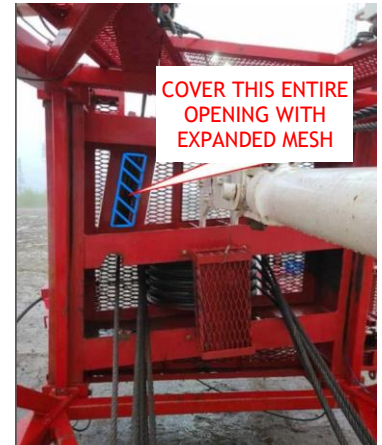
View of engineering guard to prevent improper spooling of drill line
