Safety Alert

Issue # 02-2026

ENERGY
SAFETY
CANADA

Sideboom Powerline Strike Potentially Serious Incident

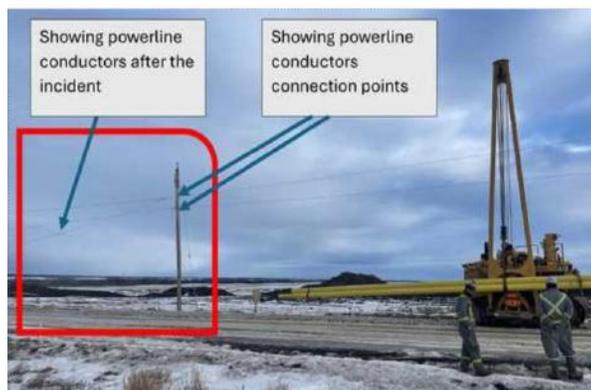
A tracked sideboom was in the process of relocating three lengths of pipe on a rural road. Three overhead powerlines were in the path, two of which were identified as the task began. After successfully crossing the first line, the boom contacted a second line that was not identified and parted an energized 25kV powerline.

No injuries occurred; this incident was considered to have a serious injury or fatality (SIF) potential due to the presence of electrical energy.

- Due to conditions, the contractor's supervisor moved the pipelayer from the right-of-way and designated travel path to the public roadway.
- The change in route bypassed physical barriers intended to prevent overhead line contact.

- The Field Level Hazard Assessment (FLHA) conducted prior to beginning work was not fully complete.
- An updated FLHA was not completed when the work scope changed; the FLHA did not account for hazards of alternate routes.
- It was not identified that the change in route resulted in physical controls intended to prevent overhead line contact being absent.
- Two of three overhead lines were identified; however, the walkdown of the new route was not complete, resulting in one line being missed.
- Cloudy conditions resulted in overhead lines blending with skyline.
- The supervisor and sideboom operator were not adequately trained for their respective roles.

- Engage with contractors to understand their supervisor competency programs.
- Verification of training and competency assessments are required for contract supervisors.
- The contractor's Construction Kick-off checklist was updated to include a requirement for the site supervisor to validate competency of their crews.
- Understand how site supervisors handle changes from planned work (i.e., Work as Imagined vs Work as Done).
- Revise how written programs address controlled and uncontrolled overhead line crossings.
