# RE-TORQUING VEHICLE LUG NUTS

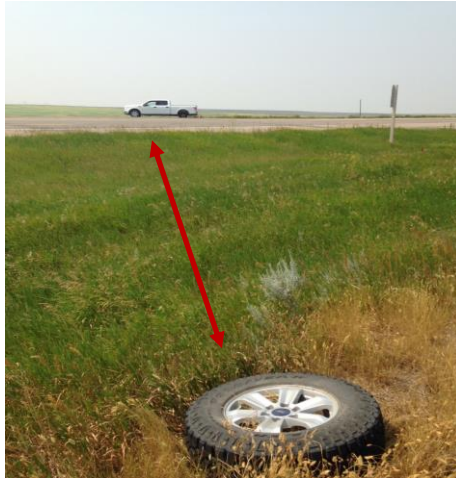
A worker was travelling down the highway in a pickup truck at approximately 100 kilometers per hour when the truck began to shake. The worker immediately slowed down and began to pull over. As the vehicle slowed, the driver and passenger saw the rear driver's side wheel roll into the adjacent ditch. The driver was able to pull over without further incident.

VIEW OF WHEEL RESTING SPOT RELATIVE TO VEHICLE

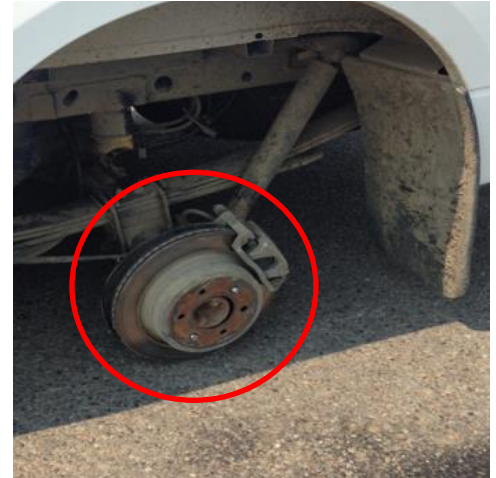
BROKEN AND MISSING LUG NUTS AND BOLTS

The lug nuts loosened resulting in the wheel breaking free from the axle.

- » Re-torquing of the lug nuts was not completed since the last vehicle service, as per the dealership's direction
- » The dealership uses re-torque window stickers to remind drivers, but the sticker was missing on this vehicle
- » There is no standard process to trigger a reminder for the employees as to when to re-torque the lug nuts

- » Follow up with dealerships to ensure the window stickers standard is understood and followed; communicate this standard to all personnel
- » Include lug nut re-torque into log books and daily inspection books to ensure drivers can verify the vehicle's last re-torque
- » Look for gaps in the fleet maintenance program by reviewing service records and verifying the last re-torque

- » Review with drivers the signs of a loose wheel or lug nut and include these items on the trip inspections. Potential signs could include the following:
  - Noticeable gap between the lug nuts and wheel rim
  - Fresh metal wear (shiny surfaces) on the wheel rim or lug nuts
  - Metal filings on or around the lug nuts
  - Cracks on the wheel rim in the vicinity of the lug nut holes
  - Radiating rust lines from the lug nuts
