# **SAFETY ALERT**

# Workers Hand Caught Between Shank Blocks

<b>Safety Alert</b> : #16 - 2010	Release Date: June 28, 2010
Incident Type: Equipment Malfunction	Country and Region: Canada, Alberta

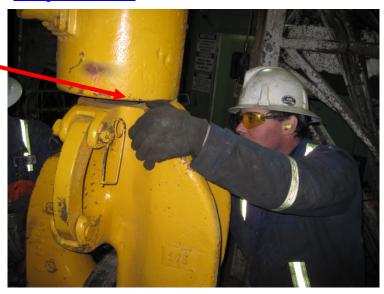
- Inspection of the block and hook found that the spring housing cap bolts were not in place. This allowed the spring housing cap to shift when the hook was under load. The shifted spring housing cap obstructed the spring retainer plate from its normal travel.
- The spring housing cap shifted into the proper position, when the hook latch was in the process of being opened, which caused the hook shank/retainer plate to travel inside of the housing cap, crushing the worker's thumb between the hook and the lower case.

When the block hook spring slammed shut the workers thumb was crushed.

- The procedure for bridling up and down should include a visual inspection of the hook spring to ensure that it is closed prior to working in close proximity of the blocks.
- Employers need to follow OEM specifications for use and operation of over head equipment.
- Report deficiencies to the OEM for recommendations to prevent reoccurrence.
