## Priority Learning Moment

### Industry-Submitted Incident Notification

#### **IN-013-2026 | Asbestos Found in Gaskets**

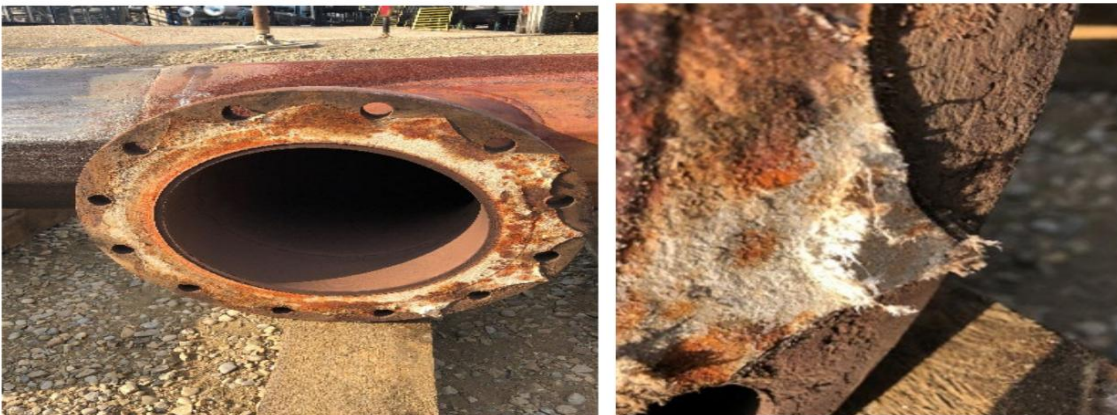
Three workers were removing the exhaust stack from a compressor at a gas plant. They were using a disc grinder to cut the bolts between the faces of a flange connection. During the cutting process, the worker inadvertently cut into the full-face gasket between the flange faces. This action disturbed previously unidentified asbestos-containing gasket material, causing fibres to become airborne.

After removing the exhaust stack, the workers further inspected the flange face gasket and questioned if it contained asbestos. All work was stopped, and appropriate precautions were taken to ensure proper decontamination processes were followed. The affected workers were sent to a clinic for baseline medical assessment.

Images: Stack flange face showing asbestos gasket

- Facility personnel were not aware of the potential for asbestos. Previous facility asbestos surveys did not identify the gasket material, as it could not be assessed at that time. As a result, it was assumed that the facility did not contain any asbestos.
- There was a communication breakdown between facility personnel and the contractor. The Safe Work Permit and Field Level Hazard Assessment (FLHA) did not capture the intended use of the grinder; therefore, all hazards and controls were not identified.

- **Leaders:** Review the Safety Awareness Bulletin with company personnel and contract workers to reinforce awareness of potential asbestos hazards associated with gaskets and gasket compounds.
- **Organization:** Health & Safety Field Advisors will review and update site orientations to ensure they clearly communicate the potential presence of asbestos in unidentified sources (e.g., gaskets, insulation, flooring, glue, tiles) that may not have been identified in a site survey. Site orientations must not state that a facility is asbestos-free, as there is a potential for asbestos material to be introduced to the site or not identified in a survey.
