## Priority Learning Moment

### Industry-Submitted Incident Notification

#### IN-016-2026 | Maintenance Sour Gas Release

Sour gas release and worker exposure when conducting preventative maintenance on a level switch.

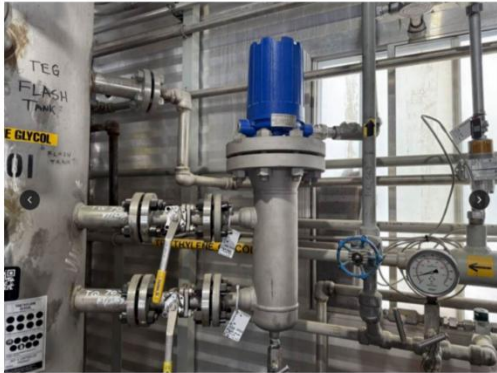
The process connection joining the electronic housing to the column was loose.

A worker was completing a preventative maintenance check on a level switch. To conduct this task, the electrical cover on the switch needed to be removed to verify that the switch was tripping. As the worker attempted to remove the electrical cover, a very small volume of gas was released from the connection where the level switch was loosely connected to the flange on the level column.

The process connection joining the electronics housing to the float chamber is sealed using a gasket and secured by tightening the process-connection nut to 225 ft-lbs. The bottom half of the electronics housing is held to the process connection nut with a set screw, whose purpose is only to keep the bottom electronics housing from rotating while the top cover is removed for access.

Close up image of assembly

- Source and purchase a torque tool to enable the site to torque the e-tube assembly prior to installation. Once torqued, the torque location will be marked on the e-tube for future reference.
- Update preventative maintenance to include caution statement from manufacturer regarding the hazards of loosening the housing and to verify the torque markings still line up prior to executing work.
- Communicate learning to targeted teams.

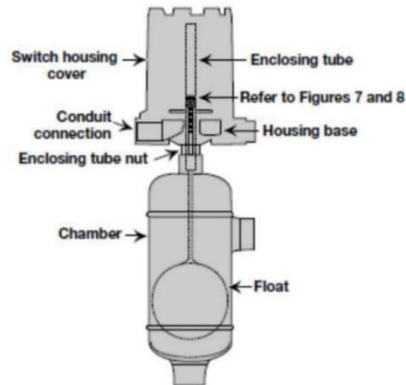
1. Improper factory torque on the process connection.
2. Electronic housing rotated during installation without loosening the set screw.  
This scenario is considered unlikely because:
  - a. No practical way to apply significant torque to the electronic housing
  - b. No visible signs of forced rotation during the investigation

Drawing of assembly with internal components
