## IN-020-2026 | ESDV Failure Due to Toggle Orientation

## Priority Learning Moment

### Industry-Submitted Incident Notification

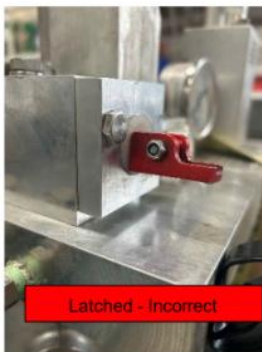
This is the "Latched" (Manual) position prior to the control device (High/Low pressure pilot switch) being satisfied.

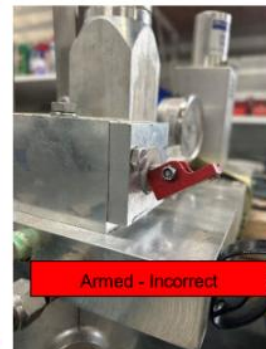
This is the "Armed" (Auto) position after the control device is satisfied. If left in this position, there is a chance that the "toggle" handle could stick and not pull in. Thus, not releasing hydraulic pressure and the ESD valve would stay OPEN.

- Raise awareness of the potential “sticking” problem with hydraulic latch block toggles if left in the incorrect position.
- Review all installations to ensure all hydraulic latch toggles are always left in the correct orientation.
- This awareness may also apply to any toggle that is required to mechanically change position when tripped, including air or fuel gas (pneumatic) installations.

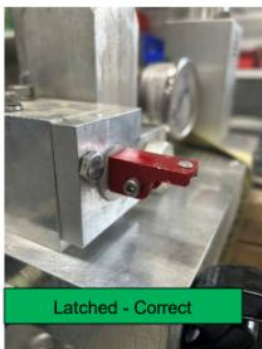
This is the "Latched" (Manual) position prior to the control device being satisfied. This is the preferred method to latch and open the valve as the toggle is already in the correct orientation when the High/Low pilot or solenoid is eventually satisfied.

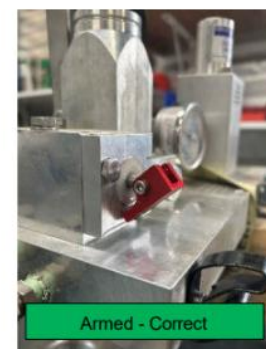
This is the "Armed" (Auto) position after the control device is satisfied. This is the preferred method to leave the toggle as it will not stick when its action is required.
