## Priority Learning Moment

### Industry-Submitted Incident Notification

#### IN-022-2026 | Truck Rack Hose Failure

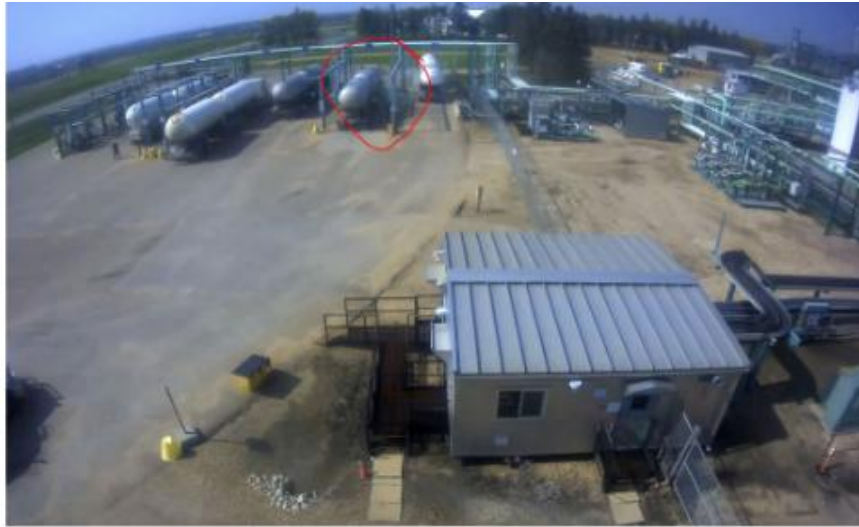
Truck rack and event location

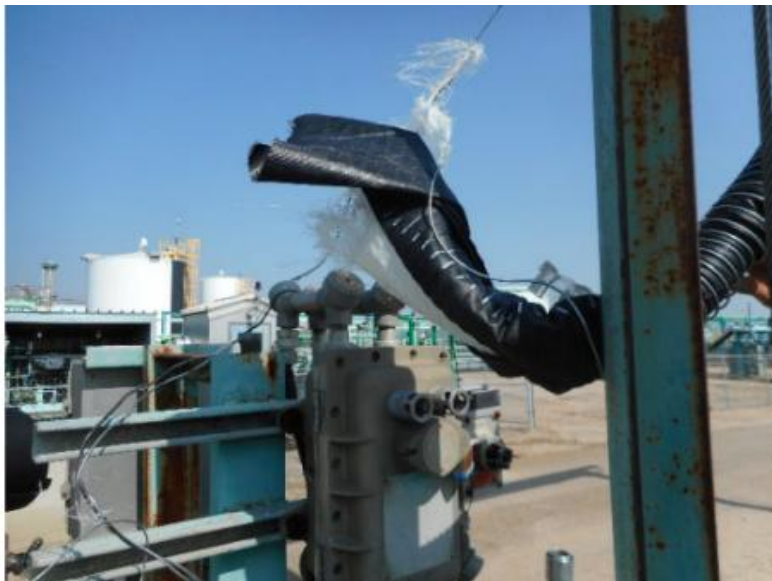
Hose condition in location after the event

- The system pressure was 1280 kPa (~185 psi) at time of failure, well below the hose MAWP.
- The truck was stationary at the time of failure, therefore, it was not “torn away”. Video evidence supports this.
- It is believed that the noted damage to the end of the hose resulted from the violent whipping action of the hose until flow was stopped and pressure dissipated.

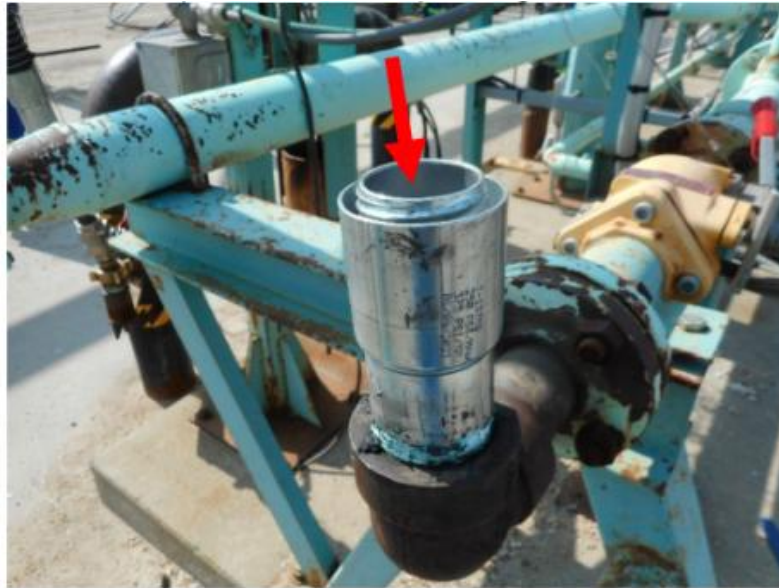
Hose separated from the crimped fitting

- The failed hose was sent back to the supplying company for inspection and failure analysis. Their conclusions are as follows:
  - The crimp diameter of the failed end and fitting was crimped to specification.

- The damage to the hose and wire displacement is much greater than is possible from a blown-off end. Typically, if an end were to blow off, it would pull 6", and the pressure would dissipate. In this case, there is ~5 ft of inner/outer wire pulled from the hose—much more than expected.

- This company hypothesized that installation practices may be a contributing factor in damage to the crimp fitting.

- Installation practice review to be conducted to confirm if it stresses and weakens the crimp joint.
- Initiate a Management of Change (MOC) to consider alternate connection joints that may be more appropriate for the application.
- If similar hose connections are in use at your facility, ensure they are being installed and inspected as per the manufacturer’s specifications and instructions, as certified by a professional engineer.

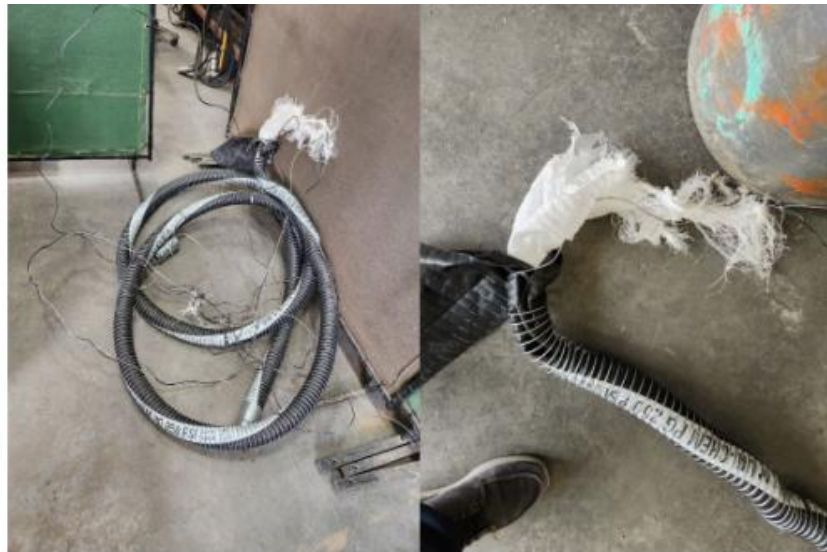
Hose after removal from the truck rack
