## Priority Learning Moment

### Industry-Submitted Incident Notification

#### IN-024-2026 | Suction Bottle Gas Release

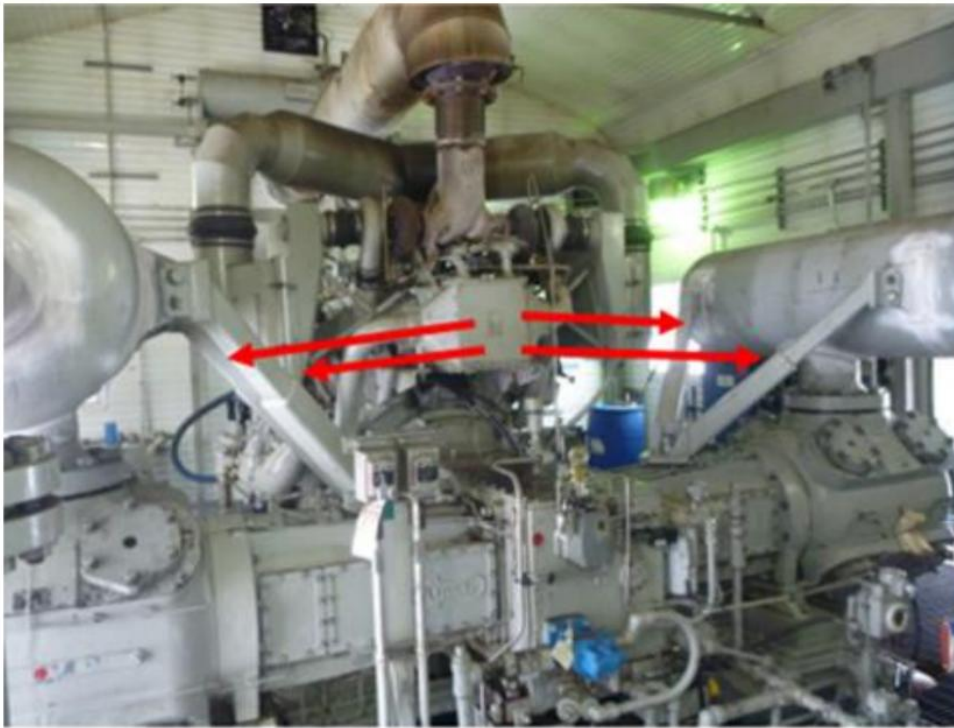
In a following year, a vibration analysis was completed and recommended implementing suction bottle cross bracing to lower overall vibration in the horizontal plane.

Without the bracing, the suction bottles were vibrating outside of manufacturer tolerances and International Organization for Standardization ([ISO 10816](#)) recommendations in the horizontal plane.

Following installation of the cross bracing, a follow-up vibration assessment was completed. Overall vibration levels were lowered from 2.38 in/s to 0.88 in/s. This correction (cross bracing) brought vibration levels within acceptable tolerance. The facility operated for 17 years within the tolerable vibration specification with no further issues.

Suction Bottle Cross Bracing

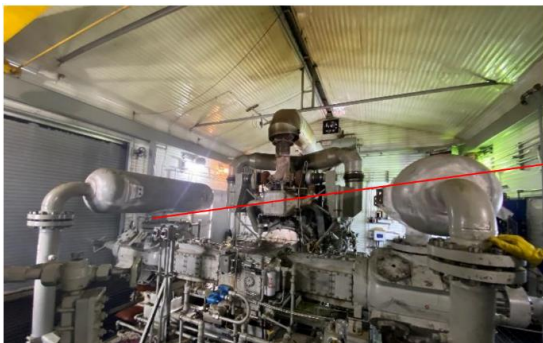
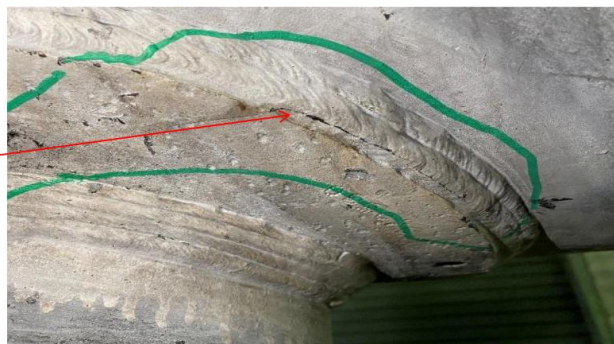
The compressor developed a crack on the north suction bottle due to high vibration, resulting in a gas release.

- Initial cracking through the repad and in the repad-to-shell weld was noted at +/- 18" in length.
- Cracking was found in the shell-to-nozzle weld, once the re-pad was removed, was +/- 10".
- Through-wall cracking was noted at 2.5" long in the neck of the nozzle.
- All evidence collected identified that without cross bracing installed, K202 suction bottles are prone to cracking every 18-24 months of run time.

Based on a review of all documentation, the suction bottle failure mode is due to vibration resonance. Resonance occurs when forced vibration (machine RPM) occurs at natural mechanical frequencies. Machinery vibration and pulsation studies highlight this concern with the suction bottles. Resonance can amplify vibration and has a high likelihood of damaging equipment. The crack aligns with vibration-induced fatigue, further supporting the above statements.
