## Priority Learning Moment

### Industry-Submitted Incident Notification

#### IN-026-2026 | Line Strike

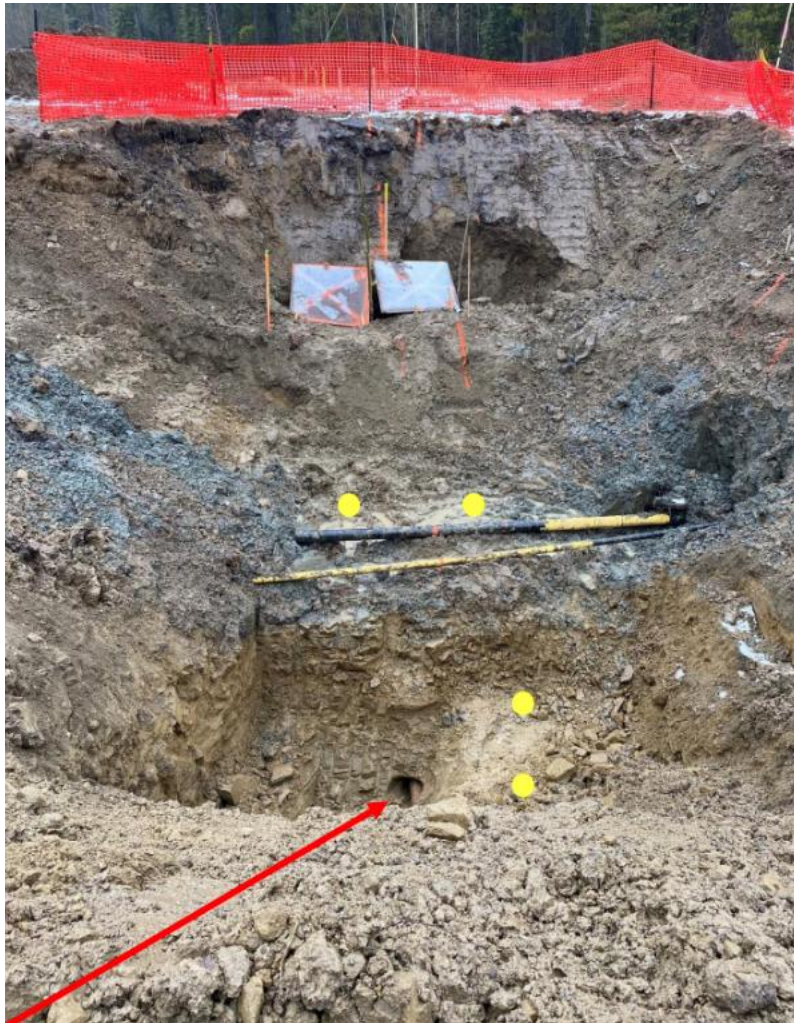
The excavator then began digging in the sandstone, as the workers onsite believed they were more than 1 m away from the Company 6" line.

At approximately 11:00 am, the excavator contacted the 6" line, causing a dent and scrape to the pipe.

Red arrow showing location of line strike. Yellow dots showing approximate location of workers at time of impact.

Workers did not follow the Company's CSOP for Ground Disturbance by conducting mechanical excavation within the Tolerance Zone.

The Company GD Supervisor proceeded with mechanical excavation within the Tolerance Zone prior to the lines being exposed by hydro-vac without communication to their direct supervisor.
