## Priority Learning Moment

#### IN-030-2026 | Dropped Blocks

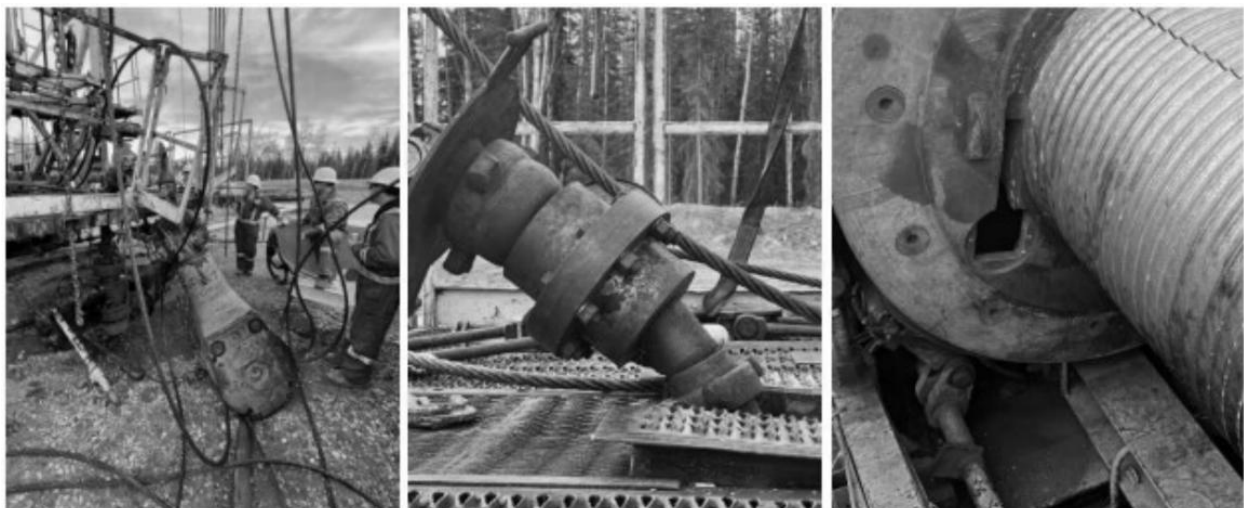
A service rig was doing a workover, running rods. The rod transfer was not disconnected from the rods, and the rod transfer cable was stretched and frayed. The Driller and Derrickhand stopped to repair a frayed rod transfer cable.

They assumed the repair job would take less than 15 minutes. However, the job scope changed from a repair job to a full replacement of the rod transfer cable. The service rig was shut down for more than two hours with the blocks positioned above the rod basket, approximately 75 feet from ground level.

When work was stopped to begin the repair/replacement task, the Driller chained the brake handle but did not engage the disc brake. During the cable replacement, the brakes cooled and released, causing the blocks to fall uncontrolled to the ground.

This event had the potential for a serious personal injury, as workers were planning their return to the direct work area only moments before the blocks fell. The incident damaged the wellhead and compromised secondary well control.

The full mechanical advantage of the braking system was not available. The combination of the brakes being slightly out of manufacturer specifications, the disc braking system not being used, the weight of the blocks and rod string on the drill line, and the cooling of the brakes over a two-hour period caused the blocks to fall.
