## Priority Learning Moment

### Industry-Submitted Incident Notification

#### **IN-032-2026 | Smoke in a Motor Control Centre: Internal Failure of a Variable Frequency Drive**

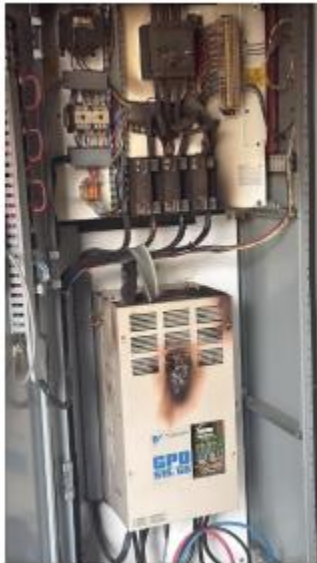
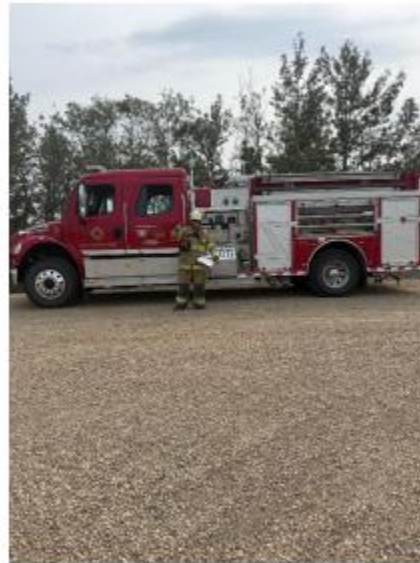
The drive had failed internally and was smouldering, melting the insulation on its wiring. All three line fuses feeding it had blown, which removed the energy source. The utility was called for an emergency disconnect at the pole. 911 was called and the local fire department, a mutual-aid industrial response team and company personnel attended.

A variable frequency drive can fail internally and overheat inside a closed cabinet. There is a great deal of plastic in a drive cabinet, and components can glow red hot and smoulder without ever producing an obvious flame. That smouldering fills the building with dense, toxic smoke, and the building's own exhaust fan can distribute it. In this event, soot was drawn through the MCC and deposited on an otherwise undamaged contactor cabinet two cells away.

*Photographs taken on scene following the electrical failure and smoke event.*

Once disconnected, the building was ventilated, and an electrician opened the panels, isolated the damaged cell from the horizontal bus bar, and inspected the bus bars and insulators before anything was re-energized. The facility was back in service the same day.

- **The electrical work was done to a zero-energy state.** The main breaker and all remaining breakers were shut off before any cabinet was opened; thermal imaging was performed through closed doors; and the bus bars and insulators were inspected for heat damage before re-energizing. Isolating the failed cell from the horizontal bus bar then allowed the rest of the MCC to be brought back safely.
