STEAM HOSE FAILURE BURNS WORKER

DESCRIPTION:

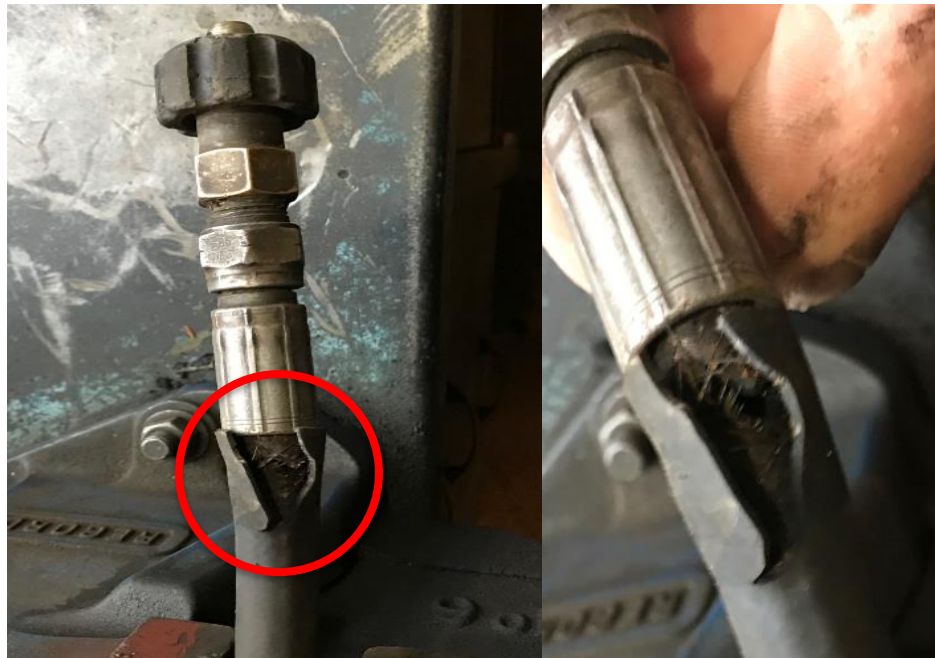
The steam hose ruptured just below the crimped fitting

The steam hose ruptured while in use.

The worker removed the hose from the shack without turning off the steam first. The position of the hose within the wellhead shack may have contributed to its failure. Bending a hose sharply by a coupling could result in weakening the hose and causing a rupture.

- Steam hoses have a finite life and they gradually deteriorate; hoses should be inspected before and after each use
- Use manufacturer standards for inspection and replacement. Hoses with any damage should be removed from service. Inspection of hoses could include: looking for cover blisters, worn spots, kinking, basketing, cuts and gouges, cover cracking and lumps
- Check tightness of clamps and valves before and after each use
- Avoid extreme flexing of hoses near couplings
- Consider turning off steam to move hoses
- Appropriate personal protective equipment should be worn when working with steam
- Consider using a shut off valve between the steam source and the wand
