RUFFNECK HEATER DAMAGE

DESCRIPTION:

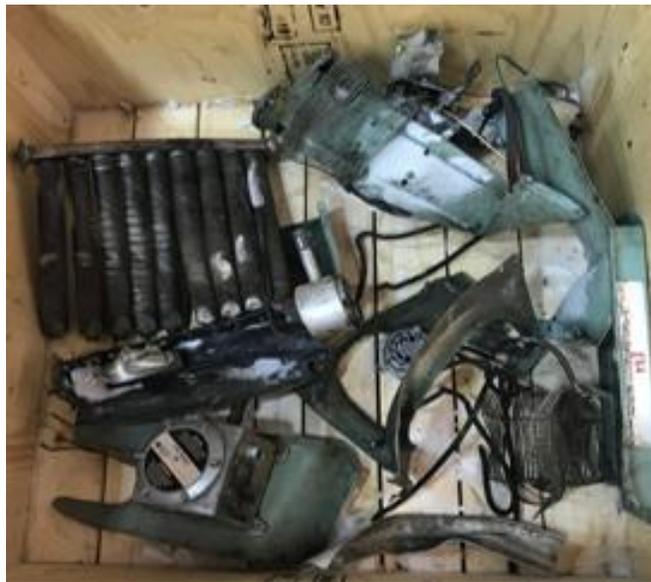
A Ruffneck-brand heater in a shack at a drilling work site experienced a static electricity rupture of the heat exchanger core. No one was injured because the crew had just completed their tasks for the day, but in slightly different circumstances crew members would have been present in the area where the explosion occurred.

DAMAGED HEATER PARTS

- Each owner’s manual has a maintenance checklist, and each heater should be regularly inspected and maintained. Maintenance should take place before every heating season.
- The heater is equipped with a single bimetal overtemperature high-limit. The heater should never be operated with the high-limit disabled or disconnected from the control circuit.
- Venting pressure of the PRV is factory-set; when it vents (pops) it must be removed from service and maintained.
- Do not tamper with or remove the warning label indicator on the PRV (see image below).

- At minimum, ensure periodic maintenance is performed at the beginning each heating season.
- Look at pressure relief valves regularly to ensure there has been no venting. If you notice paper torn over the PRV, glycol on the heater or other deficiencies, take the heater out of service and replace the core.
- If you cannot locate the owner’s manual, you can [download it](#) from Ruffneck’s website.

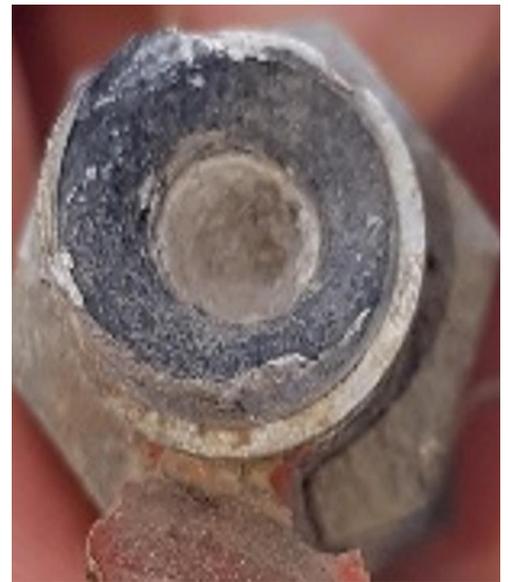
PRESSURE RELIEF VALVE HAD A BUILDUP OF SCALE

- The pressure relief valve (PRV) had vented but had not been replaced or serviced as required.
- The PRV had a buildup of scale.

- Contact points on the contactor were welded together. As a result, the element and motor were receiving constant power.
- The use of “field gas” may have contributed to the buildup of scale.
- No preventive maintenance or inspections has been performed as per the original equipment manufacturer (OEM).

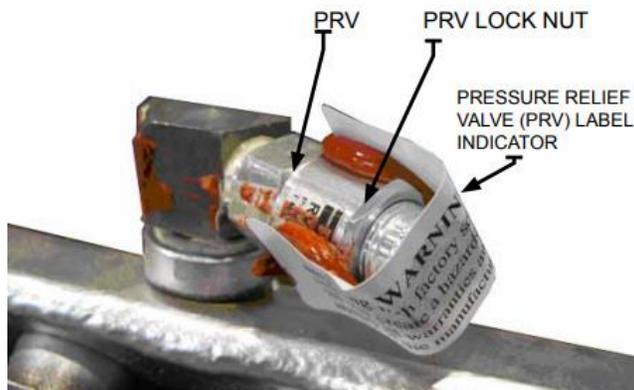
IMAGE OF MANUFACTURER’S WARNING LABEL
