## EQUIPMENT DAMAGE - TUBING STRING FALLS BEFORE SLIPS LATCHED

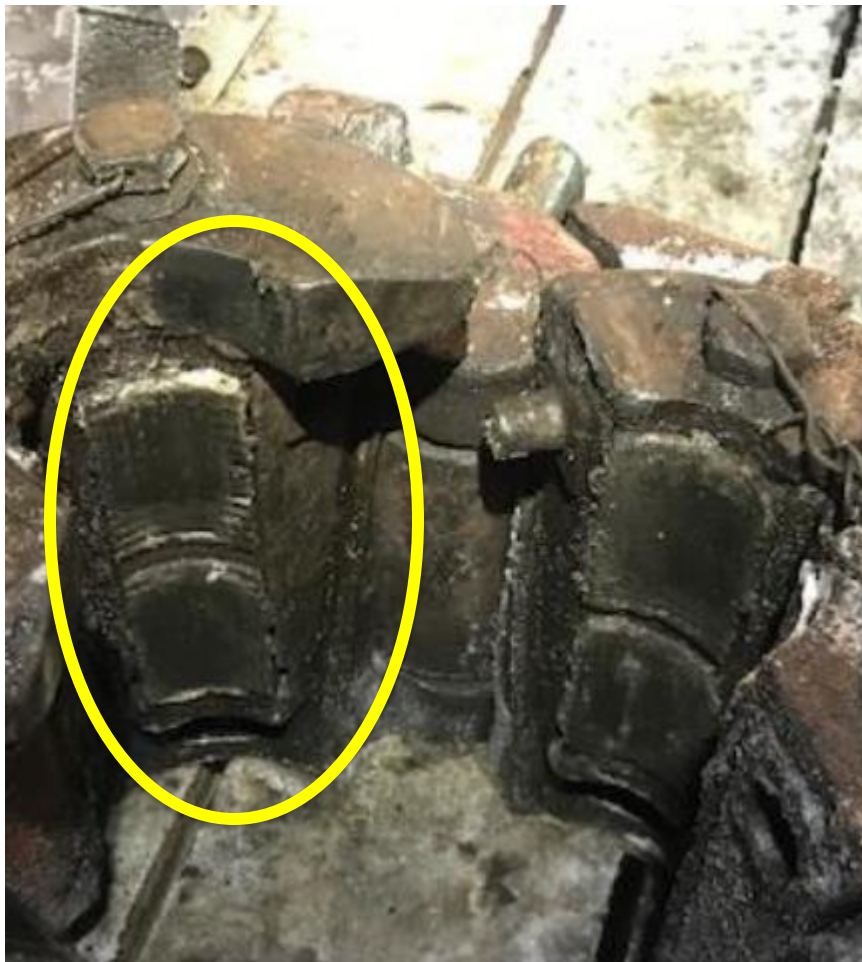
Setting plate on 40-ton MYT elevator found to be broken after string fell 8m. As a result of rapid lifting before the slips were fully set, the pipe collar was dropped onto the slip setting ring, and the full weight of the pipe damaged the elevators.

DAMAGED ELEVATORS, NOTICE INSIDE CONDITION OF ELEVATOR DIES

- Slip dies heavily impacted with debris/ice/foreign material.
- Rapid lifting prior to the slips being fully set may have resulted in the pipe being dropped onto the slip setting ring with the full weight of the stand or string impacting the elevator.

- » Make sure all slip segments are free in the “up” position when latching the elevator. If any of the segments are stuck in the down position, the elevator may not close properly.
- » Make sure the elevator and slip bodies are used with the correct size tubular (per API specification). Oversized pipe will cause difficulties such as latching partially or not at all. Undersized or oversized pipe could cause uneven stress distribution, inadequate load bearing area, and possible wedging in the slip setting ring.
- » Inspections, for both end user and service company, be conducted as outlined in CAODC Recommended Practice 4.0 *Inspection and Certification of Overhead Equipment* [https://caodc.ca/files/03\\_Recommended\\_Practices/RP\\_4.0\\_Edition\\_4\\_2016.pdf](https://caodc.ca/files/03_Recommended_Practices/RP_4.0_Edition_4_2016.pdf)
