STEERING WHEEL FAILURE

A vacuum truck driver lost control of the vehicle when the steering wheel came off the steering column.

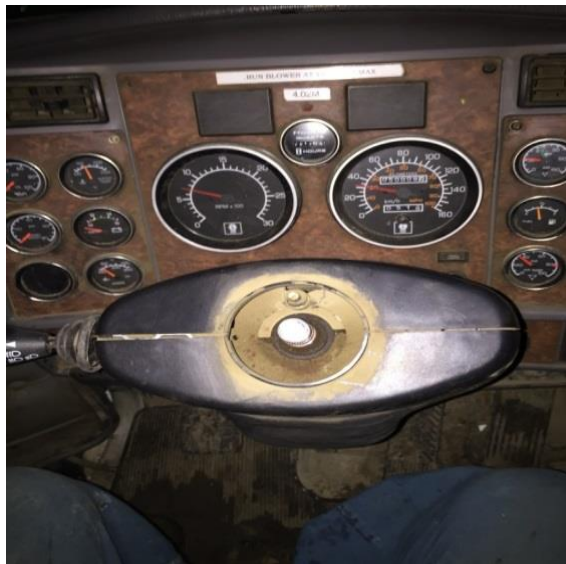
The damaged steering column

Mechanical failure of the locking mechanism of the steering wheel.

The steering wheel locking nuts were loose and came off completely when pressure was applied to the wheel. The locking mechanism failed due to the repeated use of the steering wheel as leverage to enter the cab and to adjust seat position.

- Drivers should inspect all equipment before and after use
- Steering wheel locking nuts, tabs or pins should be inspected regularly, as per the manufacturer schedule
- Owner has added steering wheel securement to their maintenance inspections
- Owner has checked their entire fleet to ensure all steering wheel nuts are secure
