WORKER INJURED BY SKID HOOK

DESCRIPTION:

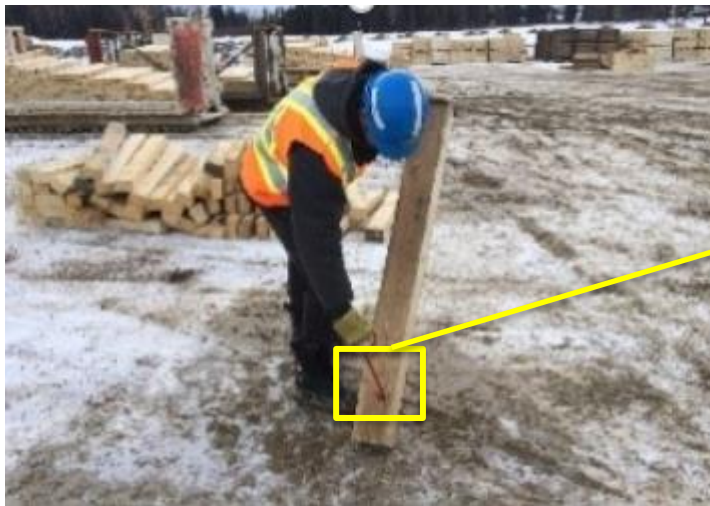
TYPICAL SKID HOOK

A worker using a skid hook to grasp timbers was injured when the skid hook struck the worker's knee. The worker was stacking timbers under pipe sections for further work. The timbers were frozen and covered with ice and snow which caused the hook to slip and contacting the workers knee resulting in a puncture wound that later became infected.

- Timbers were frozen and ice-covered
- Improper body positioning, in the line of fire

The hazard analysis did not take environmental changes into account.

- Re-issue and review the safe work practice (SWP) for skid hook handling with all affected crews.
- Conduct focused inspections on skid hook use as laid out in the SWP.
- Develop and implement a competency evaluation for skid hook use.

- Determine proximity to other workers when working with skid hooks.
- Ensure workers are familiar with and competent in the use of skid hooks.
- Workers body position not in the line of fire.
- Conduct hazard assessments prior to all tasks.
