BEAM PUMP COUNTERWEIGHTS CAN KILL!

ARE YOU MANAGING THIS HAZARD?

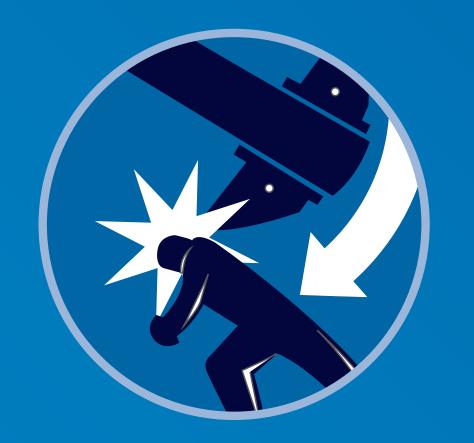
Since 1997, at least 10 worker fatalities related to beam pumps have occurred in Western Canada. The vast majority of these fatalities have been workers being struck by counterweights.

CHAINS IN SHEAVE

LOCK OUT CONTROLS

Always make sure two are in place. Follow manufacturer's recommendations

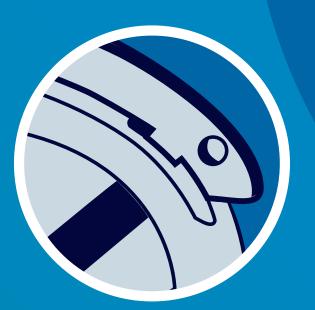
HYDRAULIC SHEAVE LOCK Hydraulic port locked out? Fork inserted around spoke?
