Injured Knee Exiting Bus

Safety Alert

Issue #:07-2017

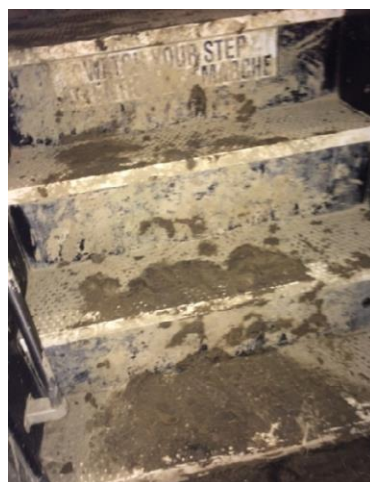
Workers were leaving a worksite on a bus. One worker went to shut the gate. As he was exiting the bus, his right foot lost traction on the steps and slipped forward, causing his left leg to bend at the knee.

During the investigation it was found that the worker did not use the handrail while descending the stairs. Though the conditions outside were muddy, the steps and walkways of the bus were cleaned throughout the day. The worker did not recognize the possible hazard of slipping while descending the stairs. He tore a ligament and partially fractured his left kneecap. Surgery was required to correct his injuries.

The mud that was on the bus steps at the time of the incident.

- Remind all workers of the importance of using the handrails when ascending and descending steps.
- Parking in an alternate location with even ground to walk on and less muddy areas.
- Crews were reminded about the risks associated with becoming complacent on routine tasks.

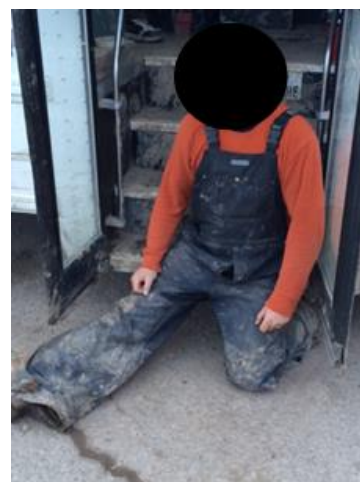
The position that the worker landed in when he slipped descending the steps.
