WORKER'S THUMB INJURED WHILE OPERATING ZIP DISK GRINDER

DESCRIPTION:

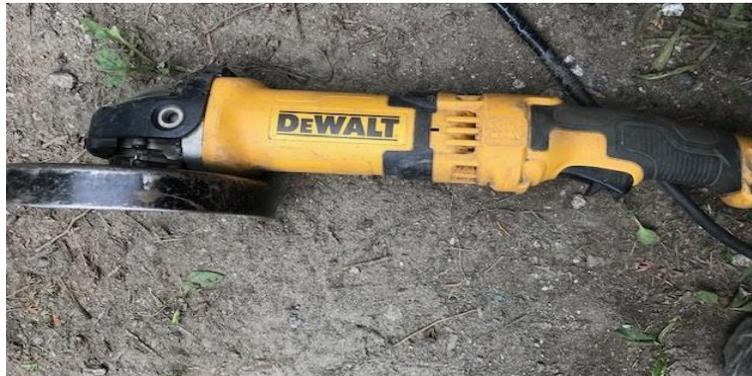
A welder's thumb was injured when the blade of zip disk grinder made contact while cutting a piece of 1/8 inch metal plate. The worker had one hand on the handle of the grinder and the other hand on the metal plate. The plate began to heat up making it warp and bind, which caused the zip disk to shift forward. The disk then contacted the back of the welder's thumb, resulting in a serious laceration.

TYPE OF ZIP DISK GRINDER THAT WAS USED

- Worker's hand was in the line of fire
- The plate was not secured (e.g. in a vice)
- Grinder should have had a side handle

The use of a straight handle-style tool is a contributing factor. The manufacturers specifications state that a side handle should be used if the grinder comes with one. The worker may have had better positioning and control of tool with a side handle.

- » The company re-enforced the importance of body positioning during job set up with all the crew members, including coaching the supervisors to take time to assess.
- » Enforce the use of both hands on the grinder when using buffing, grinding and cutting disks.
- » Worked with manufacturer to determine appropriate handle style for operations.
