OVERHEAD POWERLINE ENCROACHMENT

DESCRIPTION:

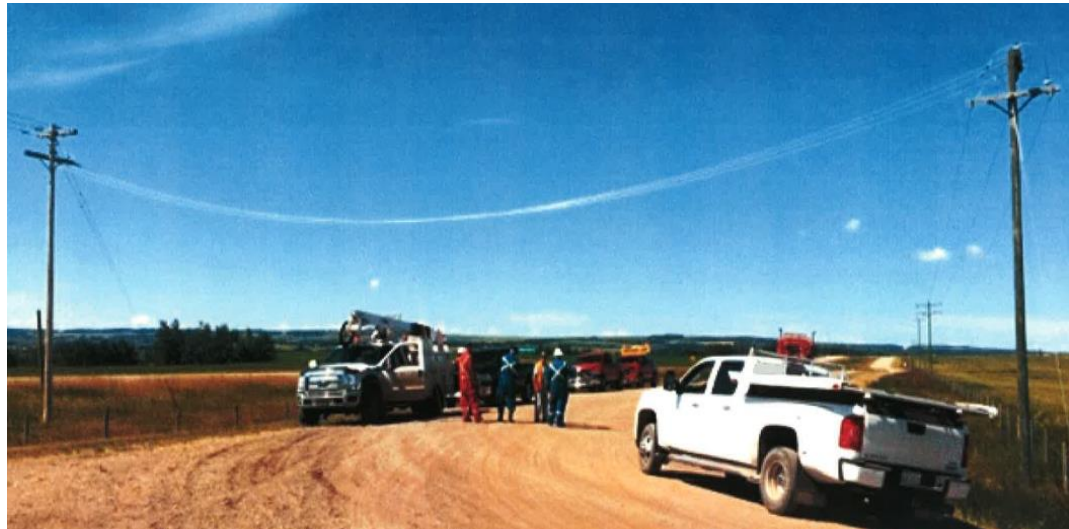
A windstorm the night before caused a power pole to shift and the overhead powerline across the road to sag

A violent wind storm moved the power pole, causing the line to sag more than 0.7m so that it was no longer a safe distance from the load being transported. In addition, the pole's anchor line was at a 90 degree angle, so the pole was not properly supported.

- Include conducting a hazard assessment of travel route prior to transportation of equipment
- Mark and measure all power lines prior to equipment movement
- Ensure the document containing line measurements and locations is on site and that those measurements are communicated to all personnel
- Pre-travel the route to ensure all appropriate signage is in place
- Re-measure height of line immediately prior to moving equipment
- Use a spotter equipped with two-way communications
- Be aware of provincial guidelines on overhead powerlines, and safe distances
- Contact the Owner for any overhead line concerns, including reporting of incidents

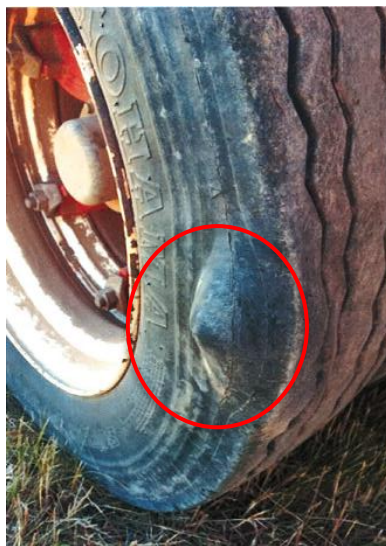
The electricity from the overhead line went through the truck and exited the sidewall of the steel-belted tire

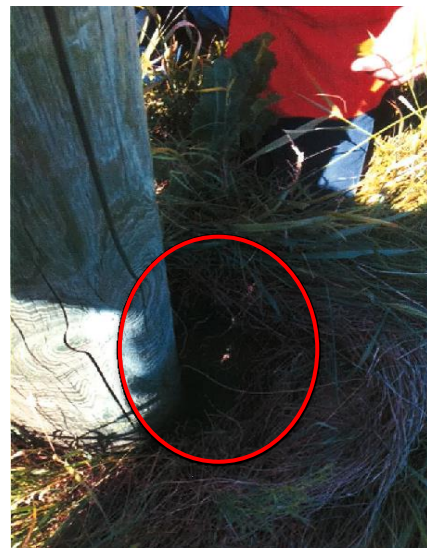
The hole in the ground shows that the pole shifted significantly in the windstorm
