Worker Struck by Pile Pipe

SAFETY ALERT

Enform

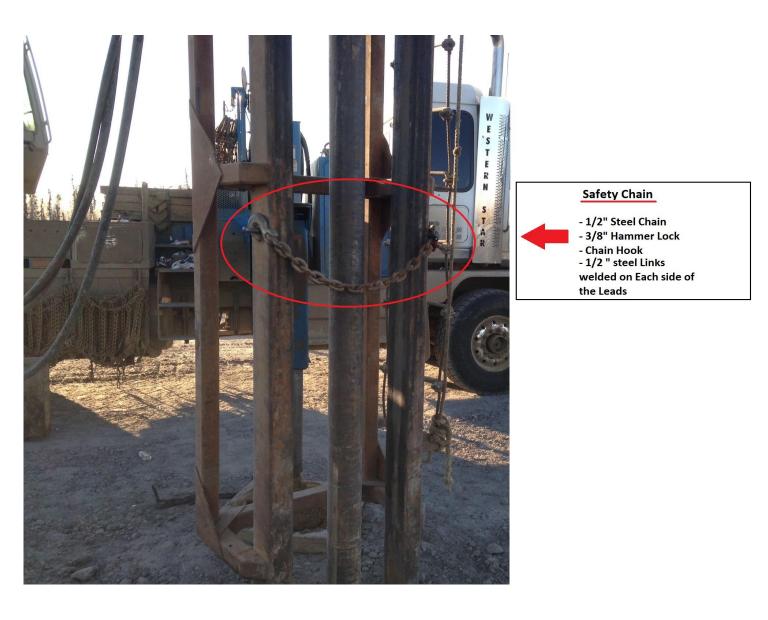
On Friday, November 14th, two workers were operating a pile driving unit with a 45 tonne mobile crane. On this day, a piece of pile pipe was standing inside the leads. When the operator lifted the hammer, the edge of the pile cap caught the collar of the pile pipe which lifted the pipe slightly. When the operator saw the collar pick up, he immediately stopped lifting the hammer causing it to bounce. The collar released from the side of the hammer allowing it to drop slightly, causing it to kick out at the bottom, striking the rigger, who, at this time was standing at the base of the leads to guide the top of the pipe onto the hammer cap pin. The bottom of the pile pipe struck the rigger on the inside of the right thigh and pushed him backwards onto the ground. This resulted in a broken femur, a fractured hip socket and a bruised lung, caused by the impact of the rigger hitting the ground.

As the hammer cap was being raised in the leads, it caught the collar on the top of the pile pipe. This was caused by the position of the pile pipe in the leads.

• The set up for pile driving procedures have been reviewed and revisions to these procedures have been made. These revisions will be implemented to prevent interference between the pile pipe and hammer when loading pipe into the leads.

- The rigger will be clear of the leads prior to the hammer being raised.
- A safety chain will be installed to contain the pile pipe within the pile driving leads.

• All operators will ensure that constant and clear communication is being made with the rigger during all pile driving processes.

• The revised pile driving procedure will be reviewed with all pile driving operators and riggers.

• The safety chain modification will be made to all pile driving units immediately, prior to continuing any pile driving work.
