SAFETY ALERT

ISSUE # 11-2020

Truck driver overcome by carbon monoxide

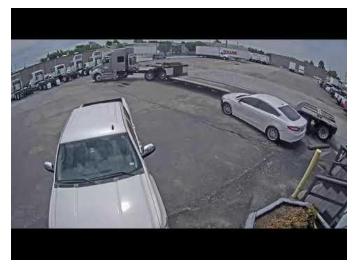
CCTV-captured this video footage as the truck struck a parked car and shortly before smoke erupted from the engine area.

- When the truck was backed up after striking the parked car, smoke erupted from the hood indicating significant problems with the engine.
- Pre-trip inspections should include checking for fluid leaks as well as exhaust leaks. Exhaust leaks are often signified by soot at or near a connection.
- The vehicle was taken out of service as per the Commercial Vehicle Safety Alliance (CVSA) 2020 North American Standard Out-of-Service Criteria (OOSC) inspection. This standard identifies critical safety violations that stipulate a vehicle be taken out of service until the condition or violation is corrected or repaired.
- If an individual recognizes he/she is experiencing a medical episode, it is vitally important to safely pull the vehicle over, stop and seek aid, either by calling 9-1-1 or an area-specific emergency number.
