WORKER BURNED IN FLASH FIRE

A flash fire in a mobile heater unit resulted in first and second degree burns on a worker's face, neck and wrists.

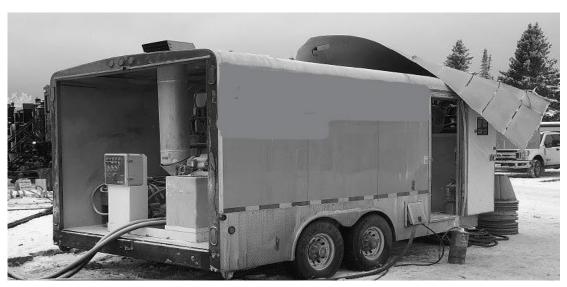
While switching the system from diesel to natural gas the worker purged the line, thinking it contained only air. As a result, gas was purged into a closed environment, filling up the heater unit. The gas ignited in a flash fire, burning the worker's face, neck and wrists where they were not covered by personal protective equipment (PPE). The worker required skin grafting in areas where severe burns were sustained. This incident could have resulted in a much more severe outcome if the worker had not been wearing PPE.

The flash fire blew out the back doors and the roof of the mobile heater unit, and caused damage to internal equipment

- Site specific hazard identification was not completed prior to conducting the task
- Worker was unaware that gas was being purged
- Worker did not have a personal multi-gas monitor
- Purging occurred in closed environment

- Heater unit doors were closed due to severe cold weather
- Not all natural gas contains odorants
- Unknown substance was purged inside a closed environment
- Gas detection equipment was not used
- Electrical motor switch was turned to "on", which created an ignition source
- Worker went back into the area to shut off fuel source, which may have further contributed to burns on his wrists

- Pre-job hazard and risk assessment should be conducted prior to all tasks
- Review safe work procedures to ensure all purging is performed in a wellventilated environment
- Prior to starting work, develop and review fire and explosion hazard plan with workers, including use and care of personal multi-gas monitors
- Consider the use of management of change protocols should the scope of a job change
- Consider the use of affixed gas monitoring whenever applicable
