SAFETY ALERT

ISSUE # 04-2024

Dozer Contacts Light Vehicle

POTENTIALLY SERIOUS INCIDENT

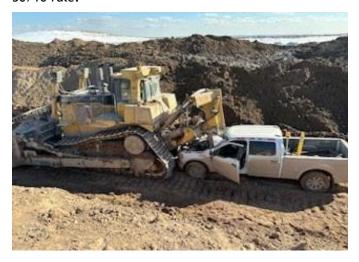
Reenactment Photo

A light vehicle (LV) entered an active work area where a dozer was back blading in a narrow corridor. The LV operator called the dozer operator via radio but received no response, however continued to approach. The dozer reversed, causing major damage to the LV. The LV operator successfully exited the LV and signaled the dozer operator to stop. There were no injuries.

The LV operator was within ~20 metres behind the dozer and not seen when the dozer started to reverse.

The only direction to approach was within a blind spot at the back of the dozer.

The narrow corridor was an unidentified hazard. No barricades were in place to keep workers or LVs out of this work area.

LV operator did not follow Safe Approach standard of 50/10 rule.

Regularly assess the strength of safeguards to ensure they are properly implemented and capable of helping to fail safely in the event of human error. Work areas and access evolve throughout a project, ensure ongoing assessment of workplace set-up, hazards and associated safeguards.

Use hard barriers where possible to separate LVs from heavy equipment in active work areas.

Regular practice and field verification of Safe Approach standards are necessary to ensure understanding and compliance.

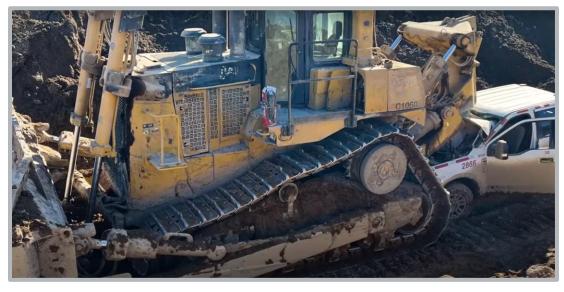
Potentially Serious Incident: Dozer-Vehicle Near Miss. Click the image to watch video.
