DRILLING FLUID SPILL ON GROUND

CATEGORY: Equipment Damage

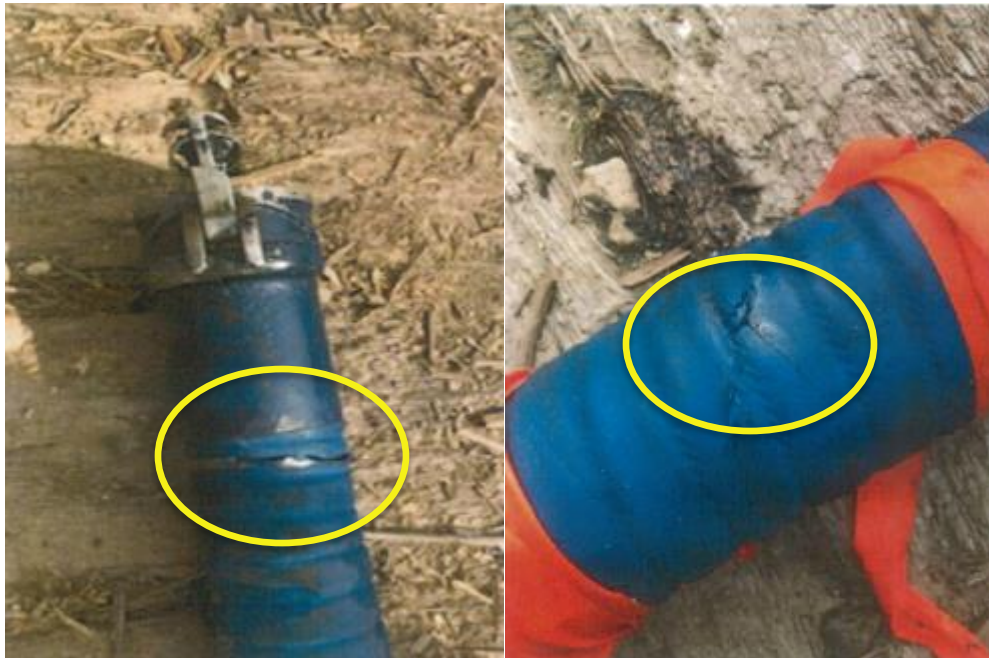
A spill on a work site was discovered near the hose lines close to a tank of drilling fluid (invert). The spill was approximately 1m³ on the ground surface. On investigation one of the hoses from the invert tank leading to a deadhead at the manifold was leaking.

FAILURE IN TWO SECTIONS OF THE HOSE CONTRIBUTED TO INVERT RELEASE

- Lack of regular inspections
- Dirt accumulation, wear and abuse has contributed to damage

The in-service date and maintenance records for the hose could not be found. In addition to the causes listed, over burden pressures may have contributed to damage.

- » Visually inspect hoses and valves before and after each use
- » All hose ends should be crimped (no banding)
- » Regularly pressure test hoses as per the manufacturer's recommendations
- » Do not drag hoses over sharp or abrasive surfaces, unless specifically designed for such service

- » Care should be taken to protect hose from severe end loads for which the hose or hose assembly are not designed
- » Hose should be used at or below its rated working pressure; any changes in pressure should be made gradually to avoid excessive surge pressures
- » Hose should not be kinked or run over by equipment
- » Follow the manufacturer's recommended procedures for the care, maintenance and storage of each type of hose
- » The periodic inspection and testing procedures, as recommended by manufacturer, provide a schedule of specific measures to detect signs of hose deterioration
