## Priority Learning Moment

#### **IN-018-2026 | Excavator Contacts De-Energized Overhead Powerline**

**This Priority Learning Moment has been submitted to Energy Safety Canada by a company wishing to share a safety lesson.**

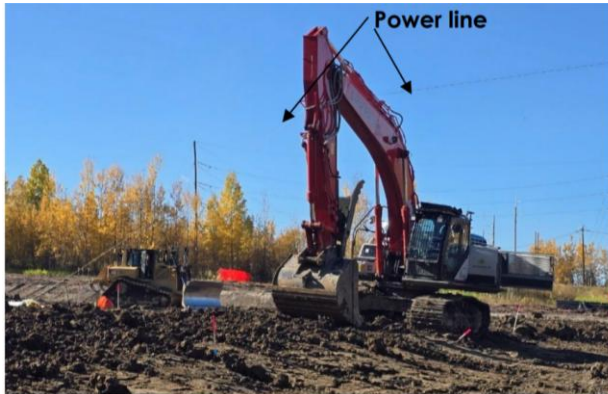
Photo 1

The equipment operator worked their way across the site, under and past the overhead de-energized line. Once at the access road, the operator stopped, swung the machine, and began travelling back to the NE corner. While travelling, the boom of the excavator was raised (see Photo 1) and contacted the overhead de-energized line. The tension from the contact caused the utility pole on the pad to break, bringing down the line and a transformer atop the pole.

- The utility pole and de-energized line were intended to be removed prior to the start of the civil scope; however, due to some miscommunication between the company and the utility provider, this did not occur.
- Due to the live electrical hazard being eliminated, the risk of contact with the de-energized line was not adequately assessed.
- Additional visual controls (i.e., rope and ribbon) to mark the exclusion zone were NOT utilized, as the additional posts were deemed to be more of an obstruction than benefit.
- The contractor workers were “tunnel visioned” on their tasks and the equipment operator failed to recognize that the equipment was within the 7 m zone of the overhead line. There was no spotter in the area at the time of the event.

- Reminder: In Alberta, the safe working distance from overhead powerlines is 7 metres. If working within 7 metres of the powerline, the utility owner must be contacted prior to work starting for approval and instruction.
- When working near overhead powerlines (live or de-energized), always ensure the use of goalposts and a spotter.
