# Safety Alert

Issue # 04-2026

## Excavator Impalement – Life-Altering Injury

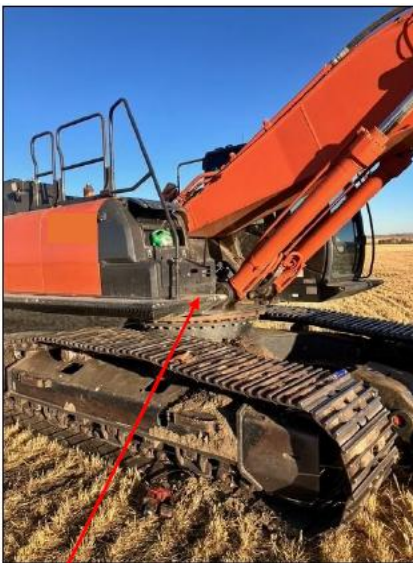
A worker was performing routine maintenance on an excavator at a worksite. Weather and site conditions were good, ruling out environmental factors as a contributor. The worker was standing on a built-in equipment platform on the excavator while completing the maintenance task.

Fig 1: Platform on excavator.

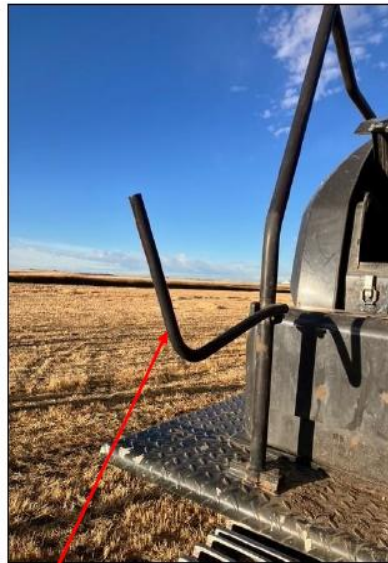
The worker lost their balance and fell from the platform, contacted the excavator mirror mount/bracket, and then fell to the ground, resulting in a serious, life-altering abdominal injury.

Fig 2: Mirror mount worker contacted.

The excavator is newer equipment, fitted with cameras that have replaced the need for a conventional mirror. With the mirror no longer needed, and now acting as a visual obstruction, it had been removed. However, the mounting bracket was left in place with its post oriented upward, at the platform's edge. The worker contacted the bracket during the fall.

- When equipment is altered, even something as seemingly minor as removing a mirror, the change needs to be assessed for any new risk it introduces.
- Hazard awareness can't be limited to a point-in-time, task-specific assessment. Crews need to maintain ongoing awareness of their surroundings and equipment, continually noticing and mitigating risks as conditions change, not only when a formal hazard assessment is triggered.
- In this case, the hazard had likely existed for some time, and familiarity with the equipment appears to have played a role in it going unaddressed.
