# Slant rig mast failure POTENTIALLY SERIOUS INCIDENT

## **Description:**

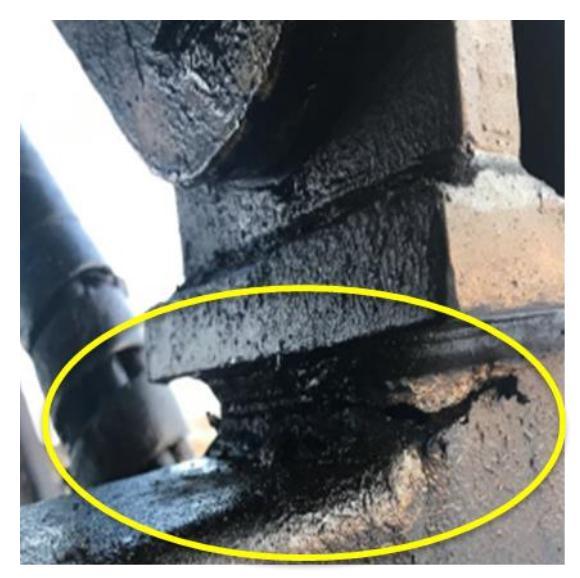
A third-party inspection revealed two weld failures at the brackets that pin the mast to the A-frame.

Off-driller side bracket cracking.

- Engineers certified in Level III and higher inspections will train field supervisors, rig managers and drillers for awareness of overall component inspections.
- Rig managers and drillers will continue to perform Level II inspections of entire mast structures, paying special attention to the carrier, ears, mast derrick pins and A-frame.

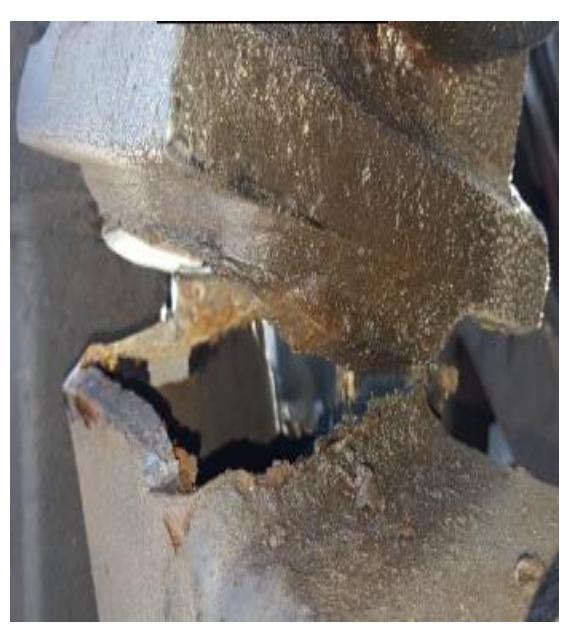
Driller side bracket. Close-up view of cracked mast.
