Heavy hauling truck lost wheel off axle

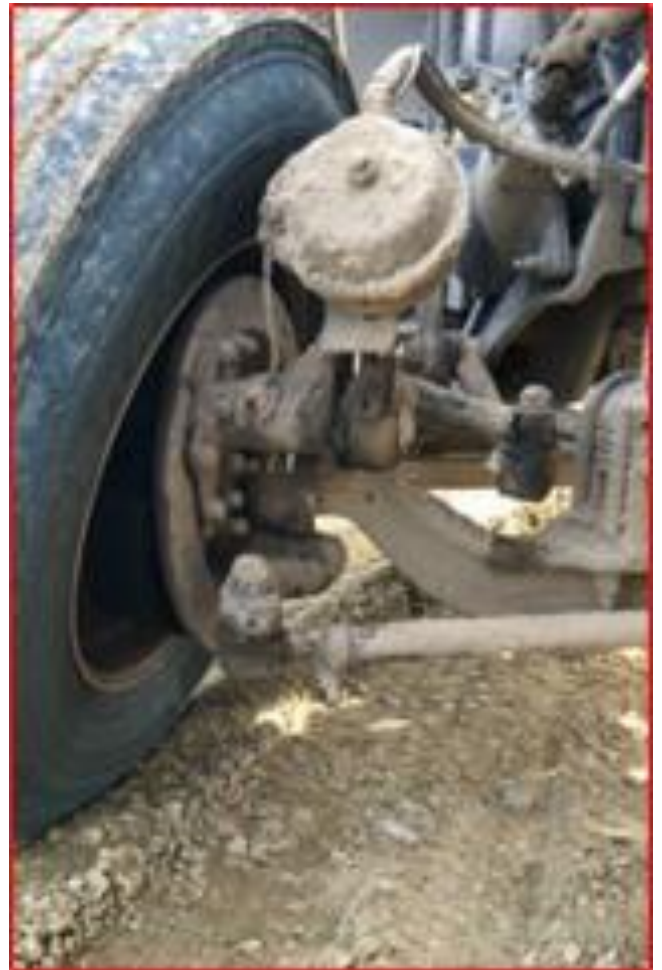
A Super-B hauler truck completed unloading and proceeded to leave a location. The driver identified that it felt like the brakes were dragging on the front driver's side wheel. The driver stopped, adjusted the brakes and proceeded to back up. While backing up, the wheel detached from the axle.

Picture of broken steering equipment

- During the pre-trip inspection, the hub oil level was not identified as low. The hub is believed to have been run dry for a period and left un-repaired.

- The un-serviced bearing and hub were run unlubricated, which allowed the hub to fail catastrophically due to the excess friction between the bearing/hub and axle. The wheel bearing failed, causing the wheel hub to become disconnected from the axle.

- Asset users must ensure inspections (including the pre-trip) are thorough, documented and shared with the appropriate department. Recording and reporting inspections regularly ensures simple items, such as an oil leak, do not lead to a catastrophic failure that can cause serious damage to equipment and place users and members of the public or worksite at risk.

- Regular mechanical inspections, as per provincial and/or federal regulations, should be completed, documented and action items should be corrected.
