# Safety Alert

Issue # 03-2026

ENERGY  
SAFETY  
CANADA

## Hydrate Release

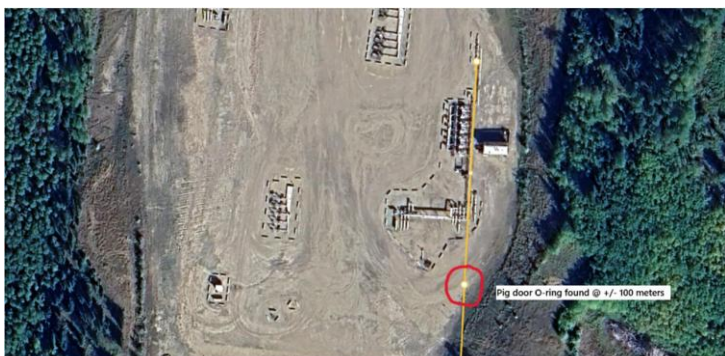
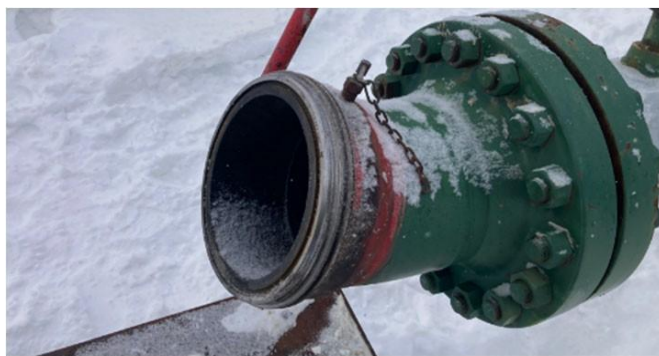
A pig was ejected through a closed pig barrel door and travelled over 100 metres across a well pad, over process piping.

The pig combined with the remaining hydrate, was sufficient to block flow from the well pad, resulting in a pressure differential of ~2500 kPa across the pig. While Operations was diagnosing the cause of the pressure increase at the pig receiver location, the hydrate released and the pig was ejected through the closed pig barrel door.

- Document when and where hydrates are observed in operational systems so they can be tracked and field supervisors can initiate remedial action as required.
- Strengthen the effectiveness of hydrate field-level assessments.
- Implement controls to ensure hydrate dissipation activities are adequately assessed and planned.
- Document locations where process equipment is in the line of fire of pig receivers and assess mitigation options (e.g., protective barriers).
- Provide minimum methanol injection guidelines for pipelines and review rates following the next set of monthly rounds.

- Investigate and field-test factors contributing to hydrate formation (e.g., methanol rates, piping geometry), and apply learnings and methodology to other hydrate-prone pipelines.
- Document limitations of pig barrel doors in pigging and pipeline hydrate documentation.
- Evaluate the effectiveness of existing pig barrel inspections practices.
- Share pig receiver and process equipment line of fire findings with Operations and Projects teams to ensure pig barrel orientation is considered in new projects and in the siting of temporary trailers and facilities.
