## Priority Learning Moment

#### IN-021-2026 | Gasket Blowout – Sour Produced Water

**This Priority Learning Moment has been submitted to Energy Safety Canada by a company wishing to share a safety lesson.**

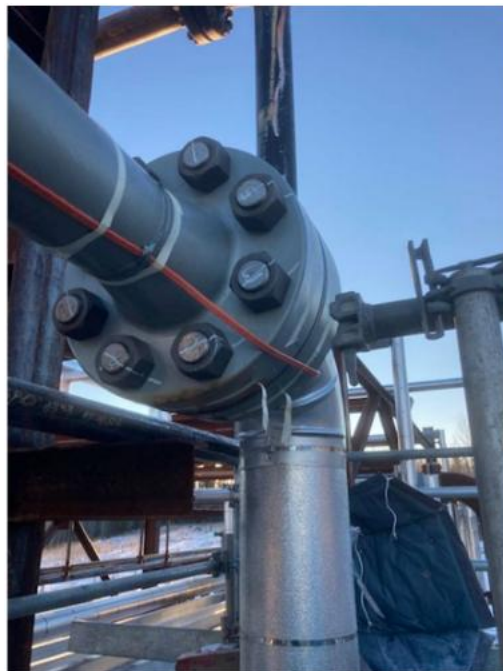
Figure 1: Flanged connection

Flanged connections are commonly used in industrial applications as interface between different sections of piping systems, allowing for safe and reliable transport of fluids. A flanged connection (Fig. 1) basically consists of two mating flanges with a gasket in between (for sealing), held together by fasteners (nuts and bolts, or studs).

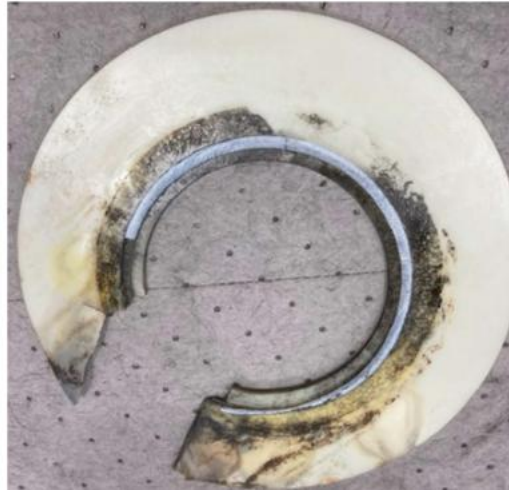
Figure 2: Failed gasket

Fig. 2 shows a failed gasket recovered from a gasket blowout in a flanged connection that led to a spill of approximately 4 m<sup>3</sup> of sour produced water from the high-pressure produced water system. The failure was attributed to deviations from original specifications and improper installation practices.

While there were no associated injuries, the potential existed for a more serious outcome, including fatality.

1. Use flanges and gaskets suitable for the intended application. Do not reuse gaskets.
2. Inspect flanges and gaskets for signs of damage, such as cracks, corrosion, or deformities, before installation.
3. Ensure gaskets are compatible with the process fluid and conditions (e.g., temperature and pressure).
4. Properly align flanges and use appropriate torque and tightening sequence during installation, as over-tightening can cause gasket deformation or flange distortion.
5. Routinely inspect for potential issues, such as leaks, corrosion, or loose bolts.

With the turnaround season upon us, there are a lot of activities involving flange joints, increasing the chances of error. Take the time to do it right. Walk the lines on startup and perform leak tests. Remember, the integrity of flanged connections is critical to the safety and reliability of our operations.
